STUDY OF FAILURE AND RELIABILITY IN MICROELECTRONICS DEVICES

2nd Quarterly Report
February 1966

CONTRACT NAS 12-72

Prepared by: Librascope Group
General Precision, Inc.

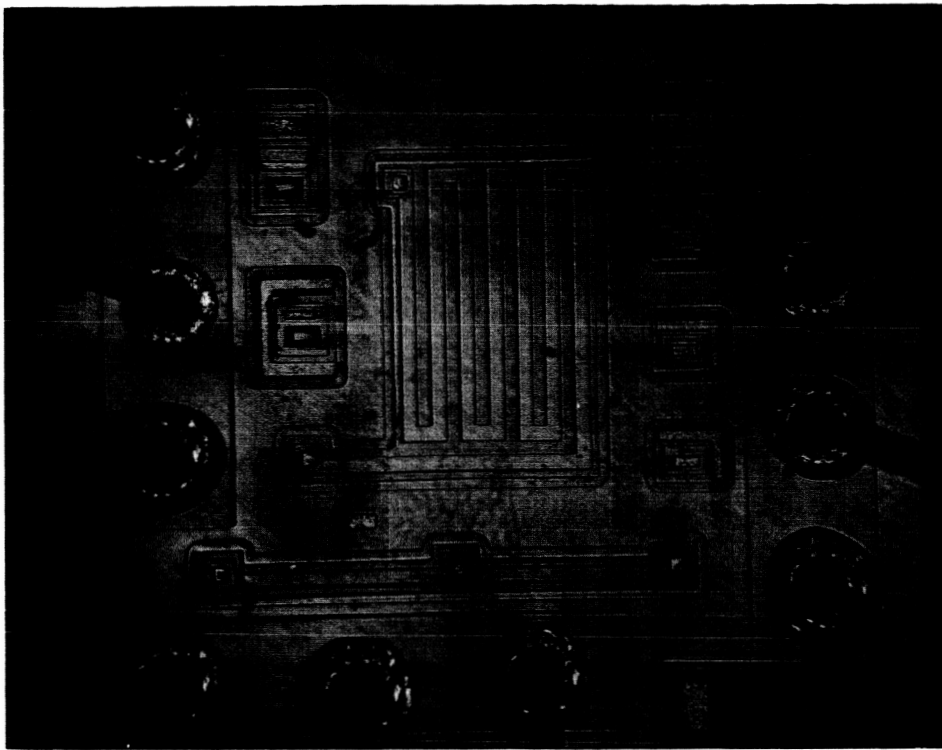
On investigation of the circuit, even prior to aluminum removal, a defect was clearly discernible extending from the anode to the cathode of diode No. 7. The defect is clearly discernible even at 100 magnification; Figure 1.

Figure 1
100 \times Magnification Device 31C After
Removal of Al Metallization

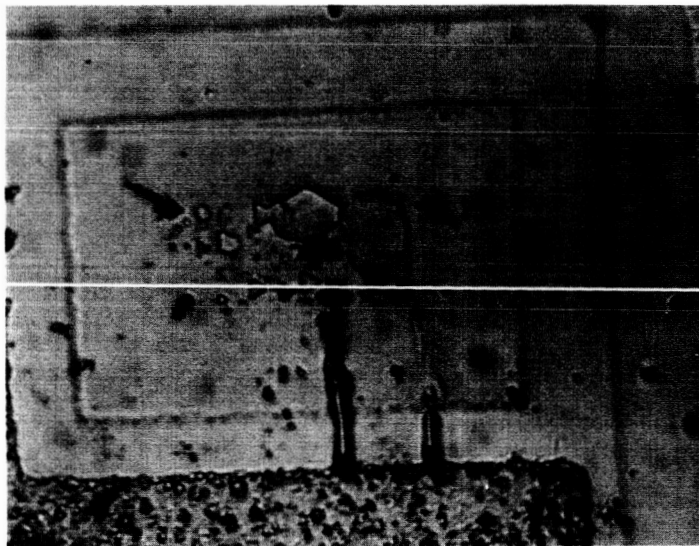
A 1070 magnification view is shown in Figure 2 after the oxide removal. The defect clearly extends into the silicon.

Figure 2
1070 \times Magnification Diode No. 7. Defects
Bridging the Anode to the Cathode

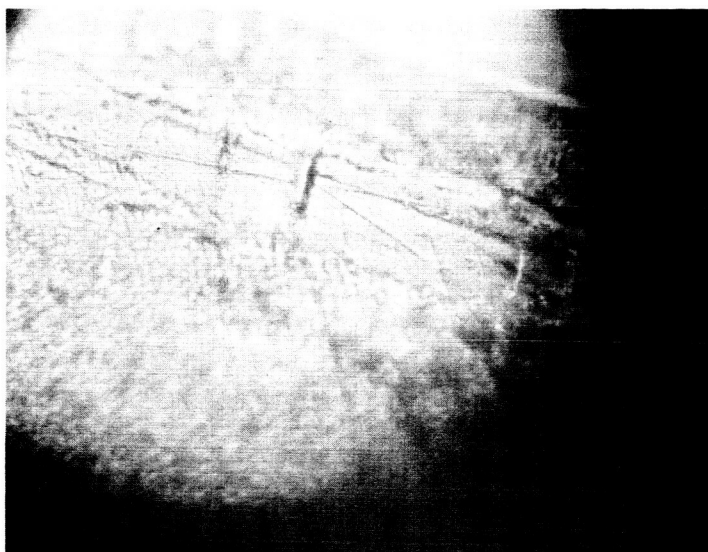
In order to study this defect further, the device was angle lapped and etched. The section was taken at 10 degrees perpendicular to the direction of the defect. Figure 3 is a 950 magnification view of the sectioned device, while Figure 4 is a schematic of the view.

Close scrutiny of the device both prior and subsequent to angle sectioning leads to the following conclusion. The defects are tubular in nature both "tubes" having a diameter less than 0.0001 inch. One of the defects was barely visible from the surface view, but was clearly evident from the sectioned view.

It is difficult to imagine that the defects were visible on the surface during fabrication. Rather, it is probable that during the step stress test the thin covering of silicon cracked revealing the "tubes" beneath the surface.

Figure 3
 950 \times Magnification Diode No. 7.
 10° Angle Sectioning of Defects

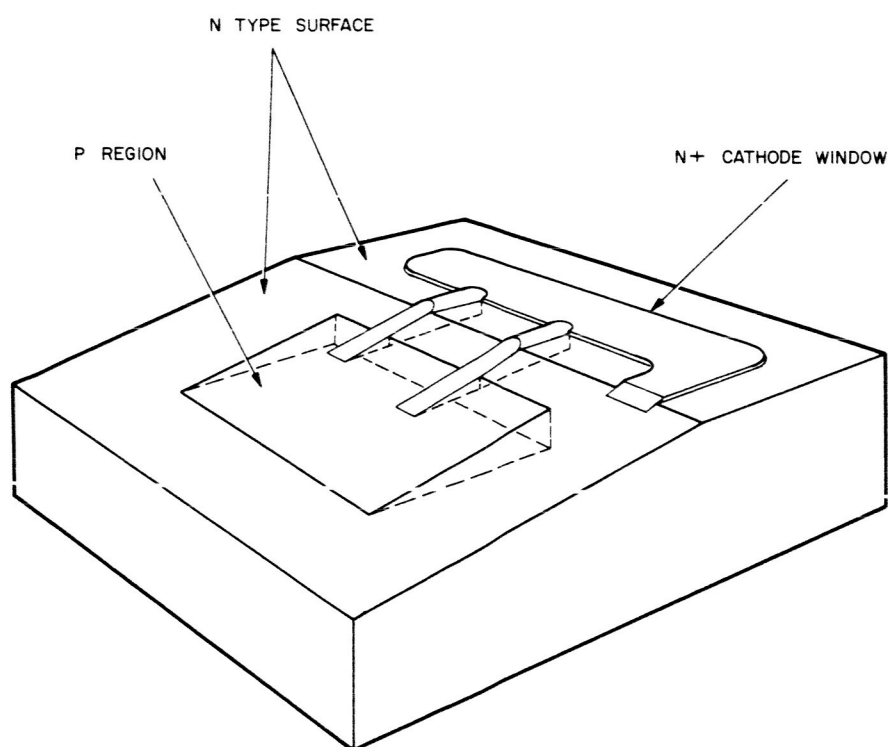
Figure 4
 Schematic Drawing of 10° Angle
 Sectioning in Figure 3
